Localized Corrosion of Alloy 22

-Fabrication Effects-

FY05 SUMMARY REPORT

*Yucca Mountain Project
Lawrence Livermore National Laboratory*

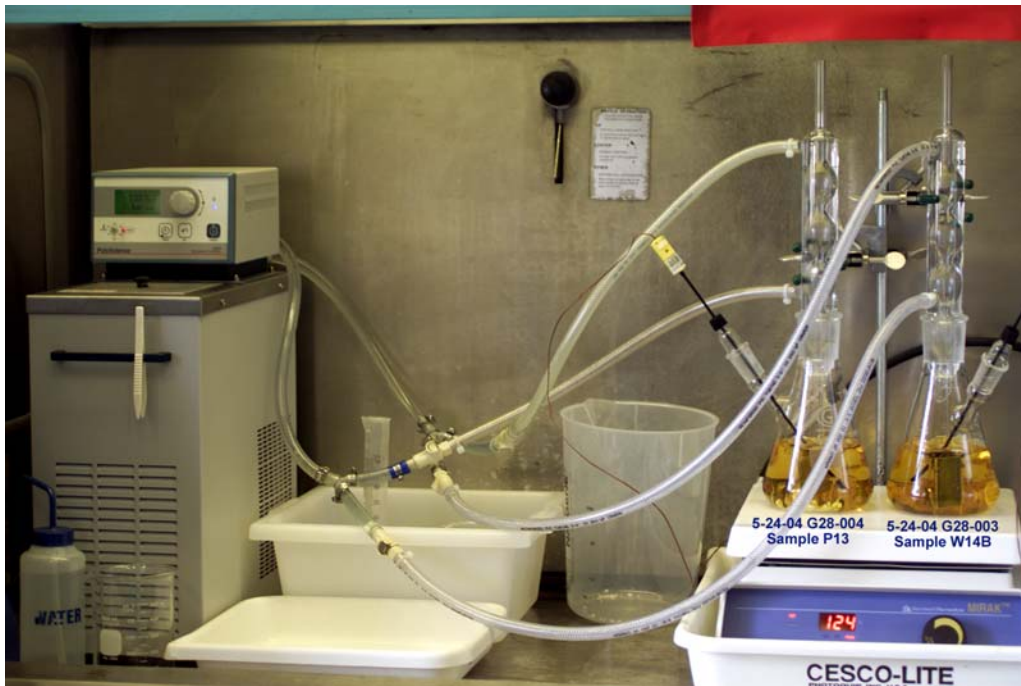
Figure 2.1 - Setting for the ASTM G 28 A tests.

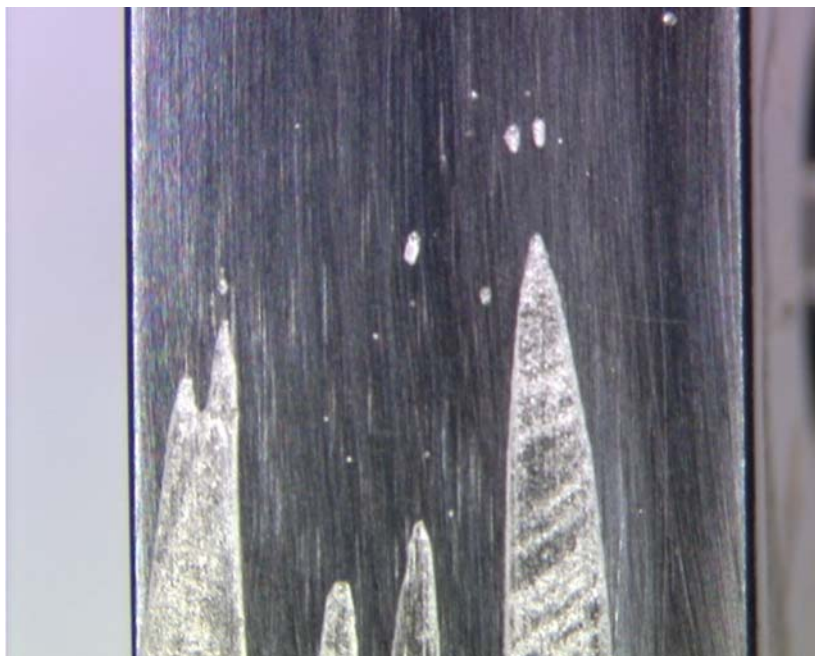
Figure 3.2 - Alloy 22 Specimen AY008 after CPP testing in 5 M CaCl_2 at 90°C showing Typical Massive Localized Attack on the ST, Non-Creviced Face

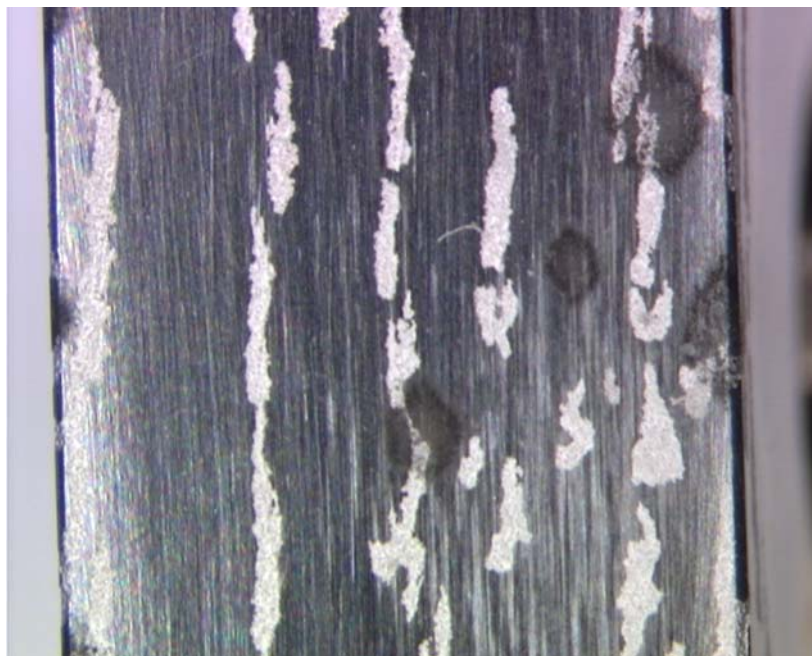
Figure 3.4 - Alloy 22 Specimen AY011 after CPP in 12 m CaCl_2 + 6 m $\text{Ca}(\text{NO}_3)_2$ at 130°C showing Localized Attack on the ST Face (non-creviced), Magnification ~X 8

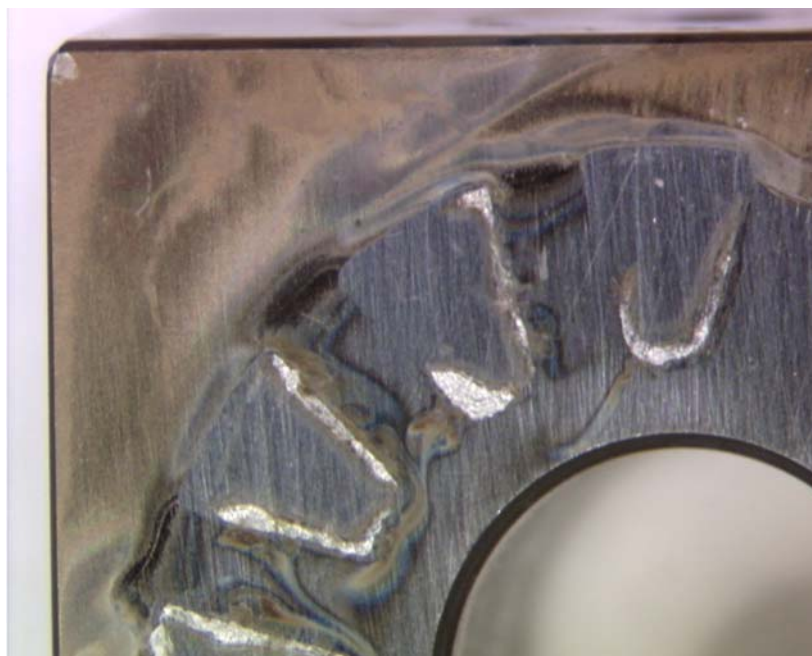
Figure 3.5 - Alloy 22 Specimen AY009 after CPP in 1 M NaCl at 90°C showing Major Transpassivity in the bold areas. Crevice Corrosion under CF, Magnification ~X 8

the corrosion mode of Alloy 22 after CPP test in 1 M NaCl at 90°C. The appearance of the specimen is typical for this type of environment. [1-2] There is a yellow and iridescent transpassivity in the boldly exposed surfaces and deep crevice corrosion following the outline of the crevice formers in the occluded areas. [4-5] The crevice corrosion attack is bright and crystallographic, showing outlines of grains and even planes inside of the grains.

Figures 3.6 and 3.7 show the effect of the temperature on the Alloy 22 susceptibility to crevice corrosion in 6 m NaCl + 0.9 m KNO₃. At 80°C, the specimen shows mostly iridescent transpassivity in the boldly exposed surfaces and little or no dull crevice corrosion under the crevice formers (Figure 3.6). At 100°C (Figure 3.7), the specimen shows a higher amount of dull crevice corrosion and also some spots of crystalline crevice corrosion. The aspect of the crystallographic crevice corrosion is similar to types of attack found in pure chloride solution (for example in 1 M NaCl, Figure 3.5).

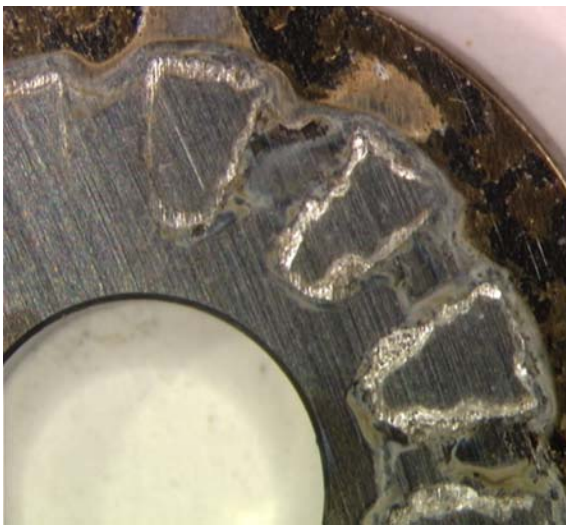
Figure 4.11– Specimen JE3328, MA polished Alloy 22 after CPP in 1 M NaCl at 90°C

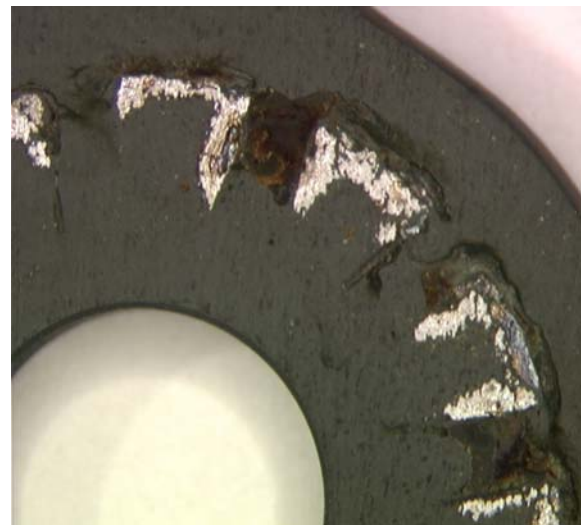
FIGURE 4.12 – Specimen JE3303, SHT Alloy 22 after CPP in 1 M NaCl at 90°C

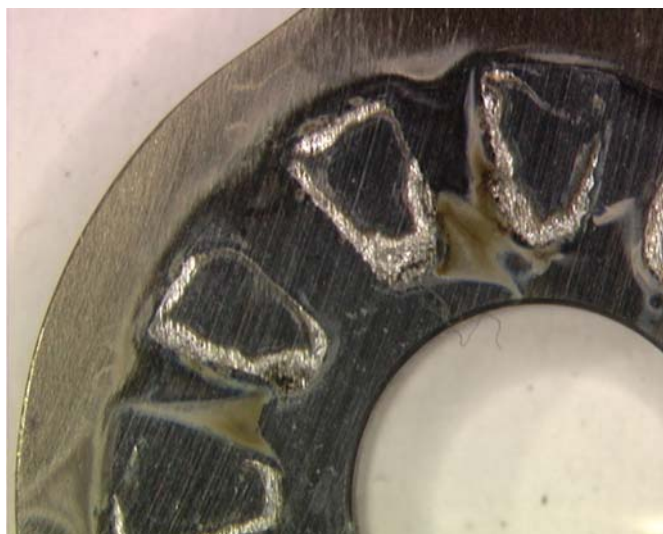
FIGURE 4.13 – Specimen JE3315, MA Alloy 22 after CPP in 6 m NaCl + 0.3 m KNO₃ at 100°C

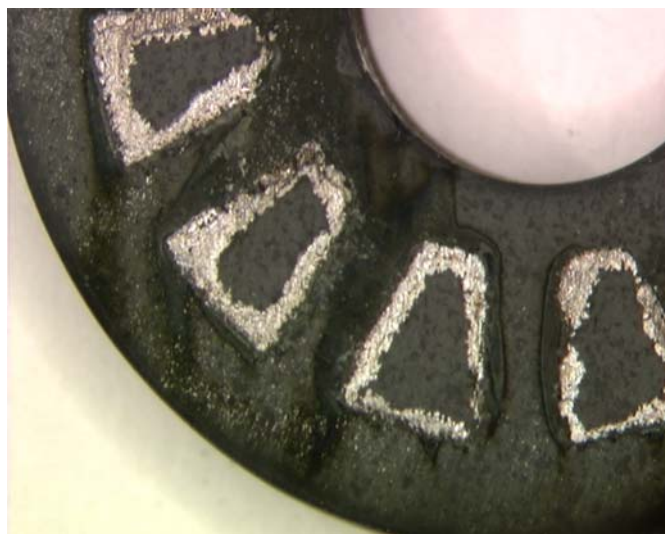
Figure 4.14 – Specimen JE3308, SHT Alloy 22 after CPP in 6 m NaCl + 0.3 m KNO₃ at 100°C

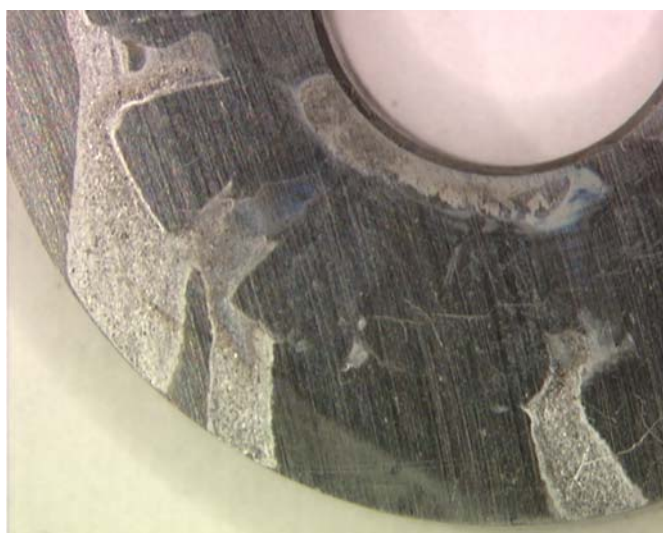
FIGURE 4.15 – Specimen JE3376, MA polished Alloy 22 after CPP in 5 M CaCl₂ at 90°C

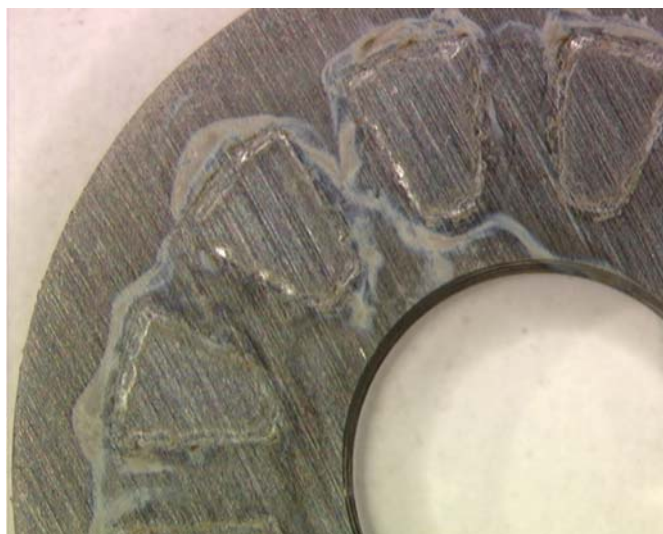
Figure 4.17 – Specimen JE3381, MA polished Alloy 22 after CPP in 0.1 m NaCl + 0.001 m NaHCO₃ at 95°C

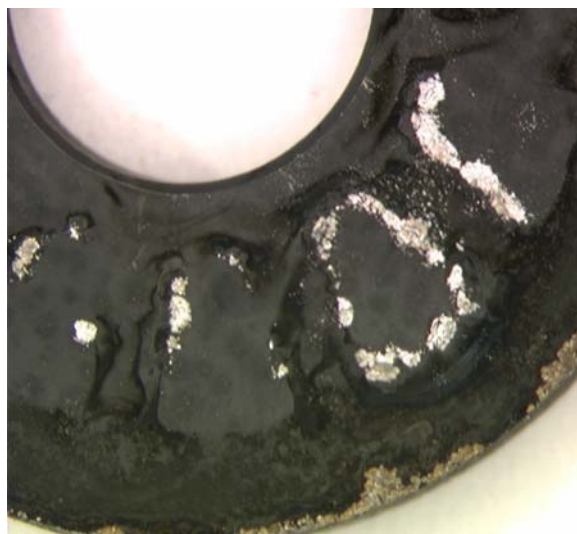
Figure 4.18 – Specimen JE3373, SHT Alloy 22 after CPP in 0.1 m NaCl + 0.001 m NaHCO₃ at 95°C

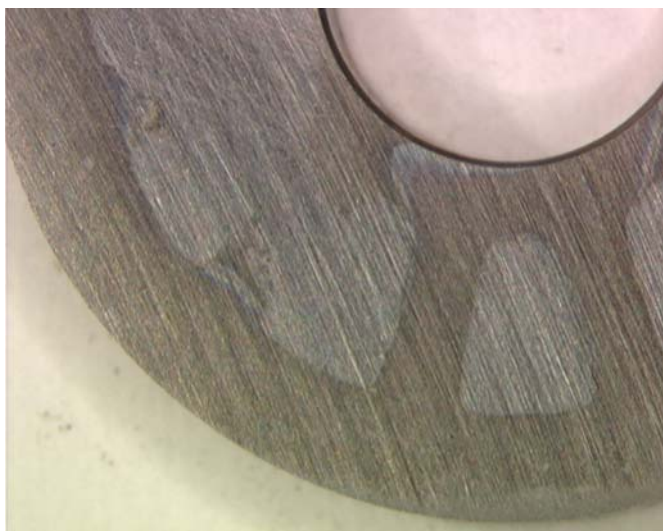
Figure 4.19 – Specimen JE3380, MA polished Alloy 22 after CPP in 0.1 m NaCl + 0.001 m NaHCO₃ at 60°C

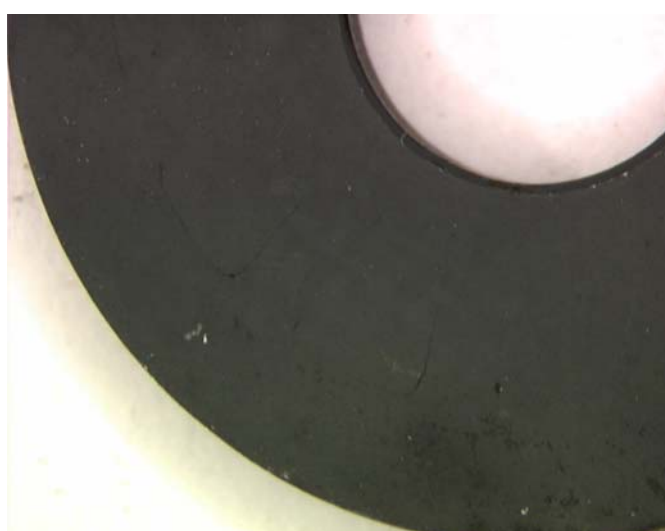
Figure 4.20 – Specimen JE3372, SHT Alloy 22 after CPP in 0.1 m NaCl + 0.001 m NaHCO₃ at 60°C

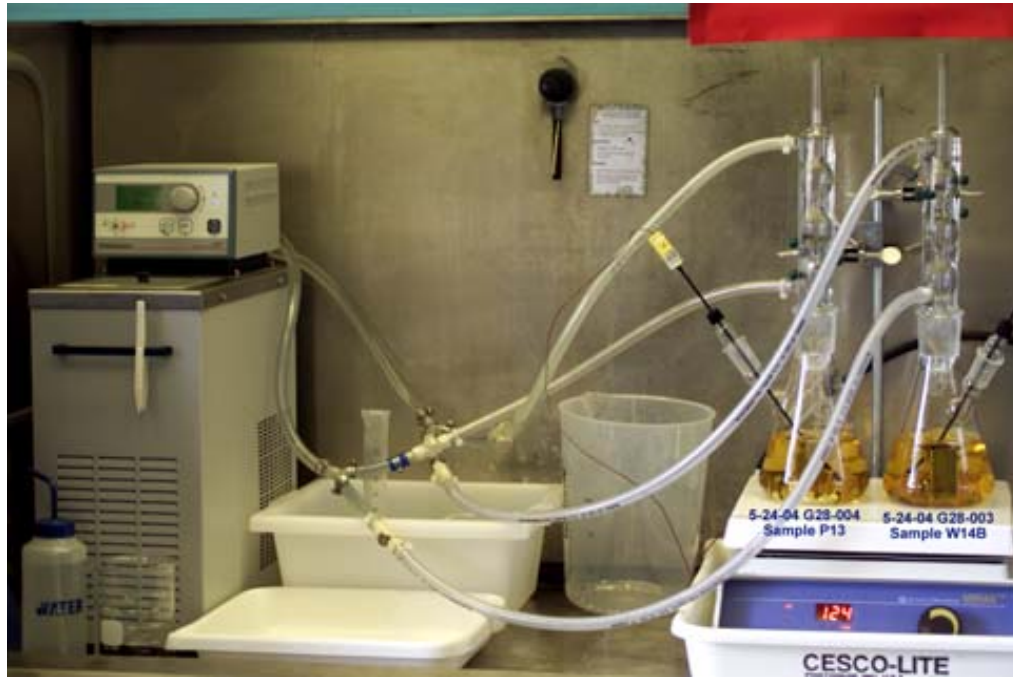
Figure 5.1 - Set-up for immersion corrosion testing

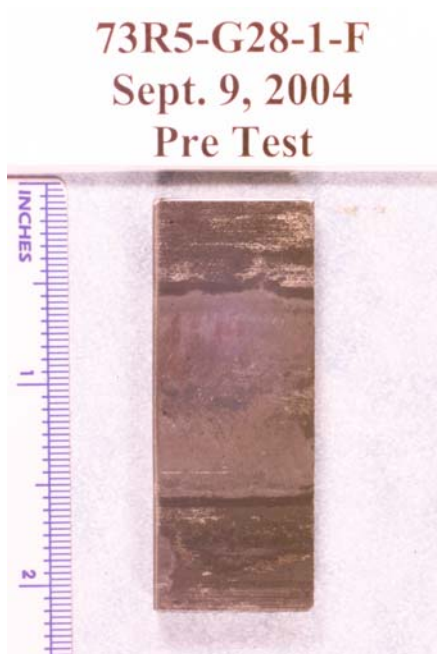
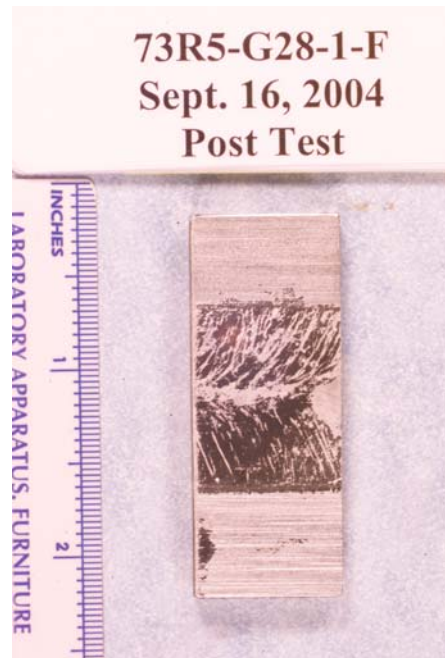
Figure 5.3. ASW + SHT Coupon 73R5 before (left) and after (right) the immersion test

Figure 5.3 shows the general appearance of the top face of the ASW + SHT 73R5 coupon. Before the immersion test, the coupon was covered by a dark (black + dark green) oxide scale produced during the solution annealing and the subsequent water quenching. After the immersion test, most of the oxide scale was washed away and only the weld seam contained remnants of this scale. Many times there were islands of uneven attack in the weld seam within the area covered by the scale. In some weld seams, cavities were found. It is not clear if these cavities were formed during the immersion tests or were weld porosity formed during welding. The black HAZ bands of IGA present in the ASW coupons (Figure 5.2) were absent in the ASW + SHT coupons (Figure 5.3).
